National Dam Inspection Program.  
Moraine State Park Dam (NDI PA-273),  
Ohio River Basin, Muddy Creek, Butler  
County, Pennsylvania. Phase I Inspection  
Report.

PHASE I REPORT  
National Dam Inspection Program

Moraine State Park Dam

1 and 5 September 1978

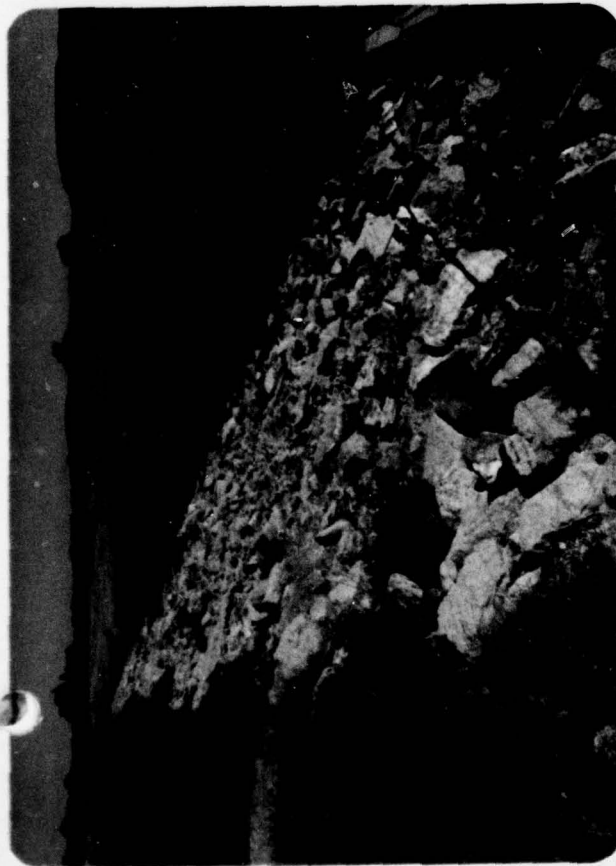
PHOTOGRAPH 8

Detailed view of exposed riprap on the downstream toe of the embankment immediately west of the stilling basin. The pipe in the foreground is Piezometer No. 8.

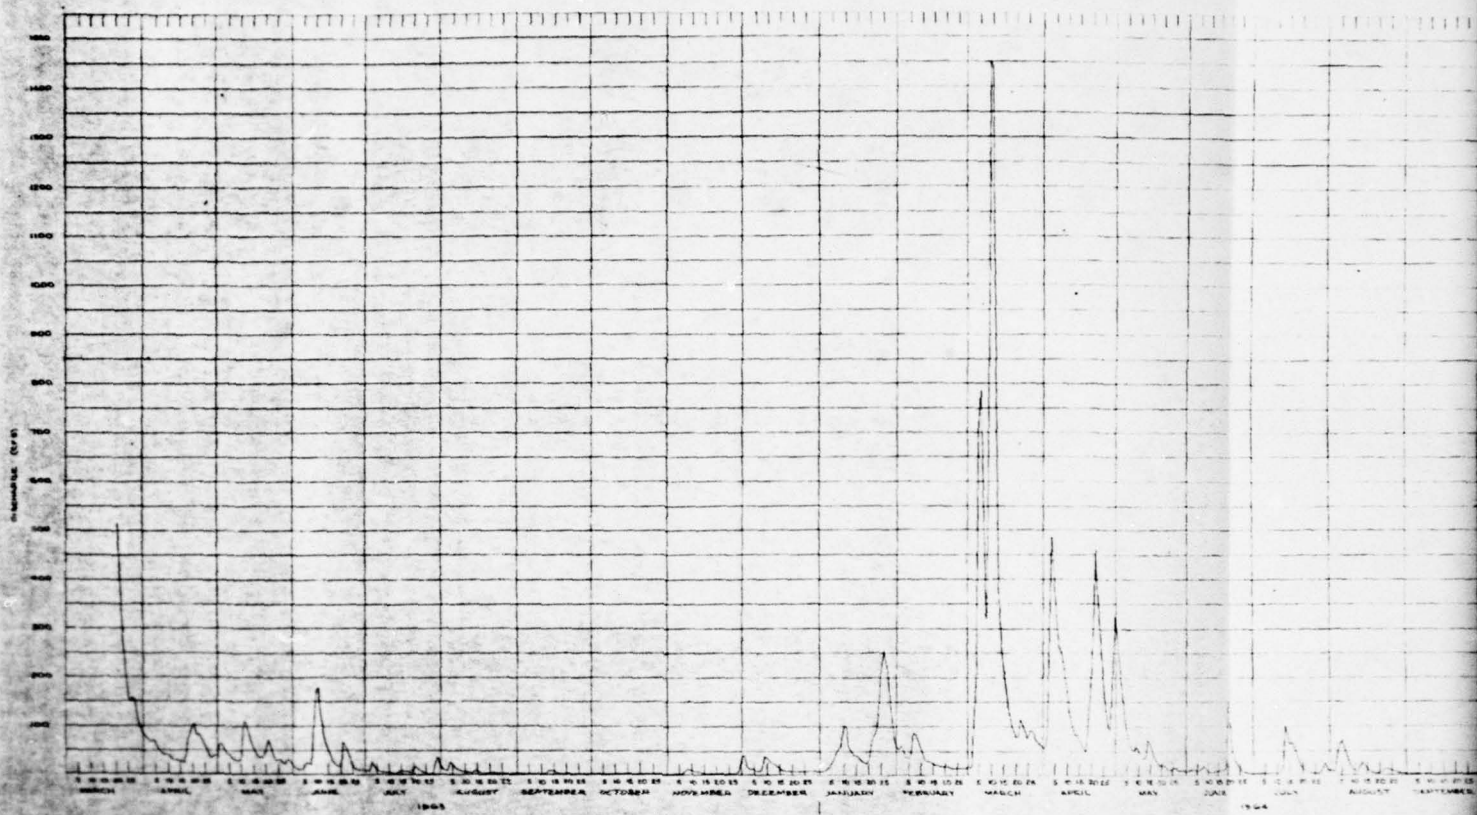
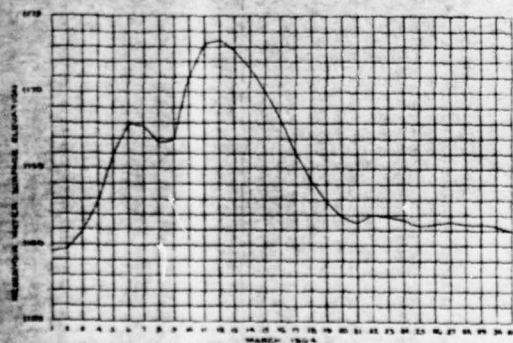
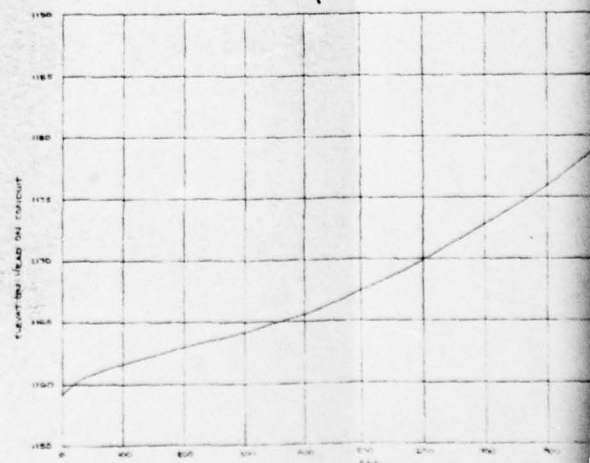
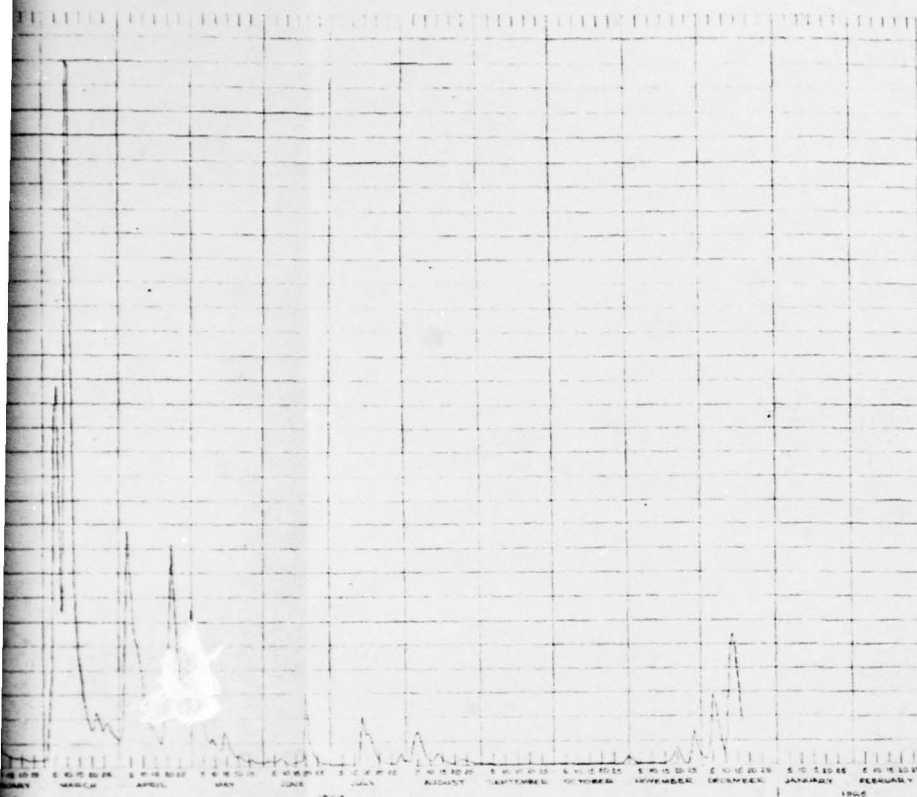
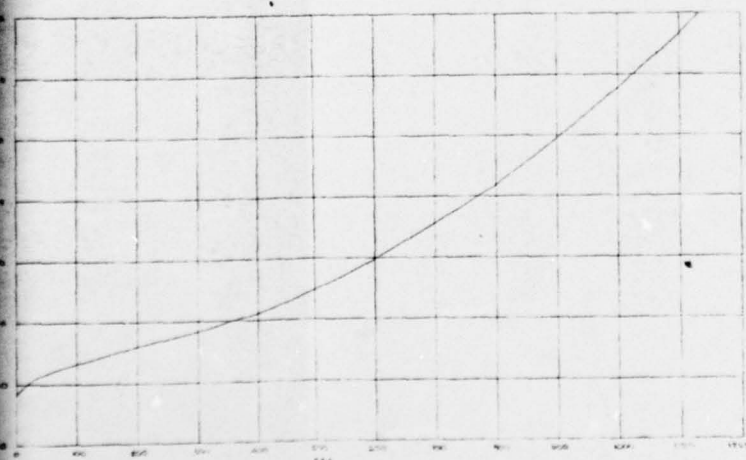
FIGURE 3

3. Appurtenant Structures. Although no specific design files are available, drawdown and flow capacity curves for the 6-foot diameter outflow conduit are presented on the contract drawings (see Figures 2 and 3; Appendix F).
